**Flood Control Project Maintenance
Levee Inspections**
LMA District Cover Sheet
Spring 2018 Levee Inspection Results

Reclamation District No. 0554 Walnut Grove

Spring 2018 Levee Inspection Results

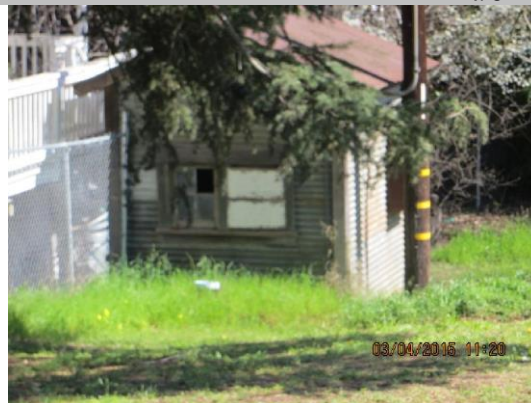
Photo 1 of 3 : UCIP_SP_2018_43726_73282.jpg

FS_ID:43726
DS_ID:18976
EP_NO: N/A
Repair Type: Non-Urgent
Crossing Status: Indicator Found
UCIP Comments: Need to verify status of crossing with town of Locke.
FIELD_STRUCT_DESC: 12-inch two water systems (a domestic and fire main) through the levee at unknown depth. Crosses levee just south of concrete block pumphouse on waterside (WS) shoulder and terminates at well house off landside (LS) toe. Gatevalve next to corner of pumphouse off LS toe. (12-inch pipe authorized under Permit No. 12944, 1980 - Sacramento Housing and Redevelopment Agency; transfer approval for Plans No. 12944 from Sacramento Housing and Redevelopment Agency to the County of Sacramento - Department of Public Works authorized under Permit No. 12944-A, 1982 - County of Sacramento Department of Public Works)
FS Date: 3/4/2015 4:49:00 PM

Pumphouse off LS toe.

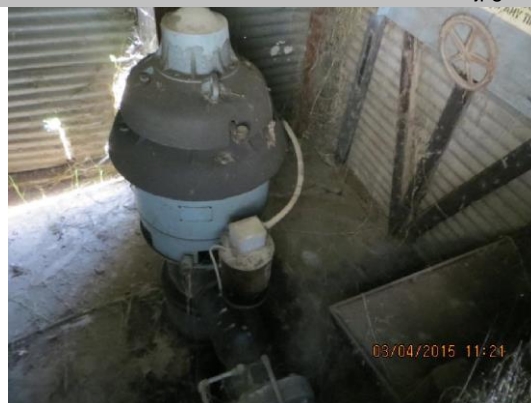
Photo 2 of 3 : UCIP_SP_2018_43726_73281.jpg

Pump over well inside pumphouse on LS toe.

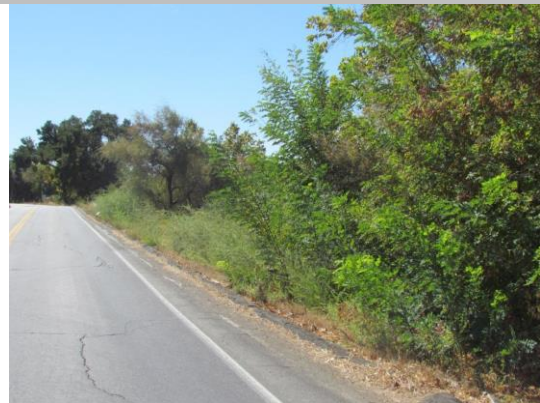
Photo 1 of 1 : SP_2018_RD0554_176_31_20180305_00009.jpg

Comment Code						
Inspector Comment						
FS_ID:50026 DS_ID:20915 EP_NO: 3360 Repair Type: Urgent Crossing Status: Not Found UCIP Comments: 7/25/2016 Coordinated with District Engineer, Gilbert Labrie with DCC Engineering. He will investigate the pipe and coordinate with PG&E to find out additional information regarding the fate of the pipe. (DWR UCIP - omagana)3/04/2015 No markers found. Need to contact owner to determine status of crossing. Recommend having owner install markers per CVFPB Title 23 for active pressure line. Owner will need to coordinate with CVFPB. (DWR UCIP - omagana) FIELD_STRUCT_DESC: Gas line along and through the levee, 3.5 feet below the crown. (gas line authorized under Permit No. 3360, 1962 - Pacific Gas and Electric Company [PG&E]) FS Date: 7/25/2016

Looking downstream waterside levee slope from levee mile 0.08-0.30.

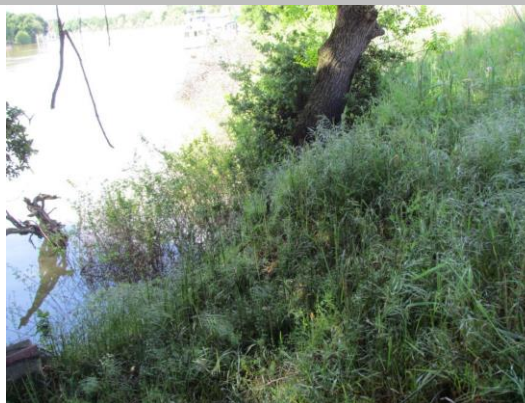
Photo 1 of 1 : SP_2018_RD0554_176_11_20180305_00003.jpg

LM Start	0.10	Rating **	M	Issue No.	11
LM End	0.10	Issue Type +	Ma	Location *	WS
Category	Earthen Levee			GPS Latitude/Longitude	
				Start	End
Item	Erosion / Bank Caving			38.248262 °	38.248262 °
				-121.509901 °	-121.509901 °
DWR ID	DWR_RD0554_01_s_2014_11				
Comment Code					
E1 : Note and monitor erosion site.					
Inspector Comment					
This is not a new erosion site, repairs are needed. One tree has fallen into the Sac River at the erosion site. This site can be seen better from the river by boat. The wild grapes blocks the view from the waterside shoulder looking down the slope. Rated as M because it is an oversized levee section.

RD 554 Waterside levee slope erosion into the bank, the wild vegetation growth blocks the view.

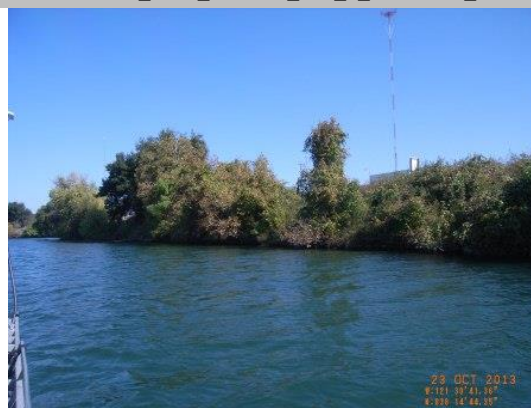
Photo 1 of 2 : SP_2018_RD0554_176_1_20180305_00001.jpg

LM Start	0.26	Rating **	M	Issue No.	1
LM End	0.36	Issue Type +	Ma	Location *	WS
Category	Supplemental			GPS Latitude/Longitude	
				Start	End
Item	2015 USACE Erosion Survey, DRAFT			38.246222 °	38.245017 °
				-121.510878 °	-121.511740 °
DWR ID	DWR_RD0554_01_f_2016_1				
Comment Code					
Inspector Comment					
2009 - Tension cracks on road on top of levee. Erosion into the levee slope and mass failure. 2013 - Short vertical sections at bank toe. 2015: No observed changes. [2015 Site ID: SAC_27-0_L]. 2018 - No changes noted. LMA confirms no changes, however levee is oversize.

USACE 2013 Photo #1

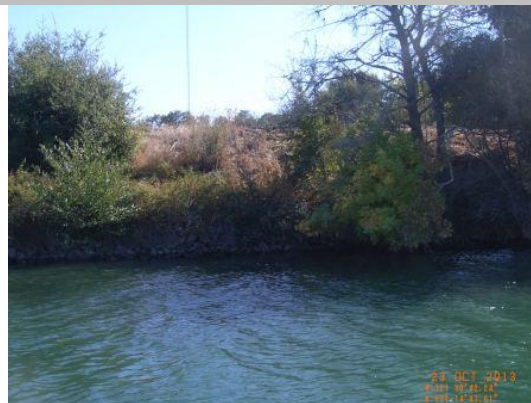
Photo 2 of 2 : SP_2018_RD0554_176_1_20180305_00002.jpg

LM Start	0.26	Rating **	M	Issue No.	1 (cont)
LM End	0.36	Issue Type +	Ma	Location *	WS

USACE 2013 Photo #2

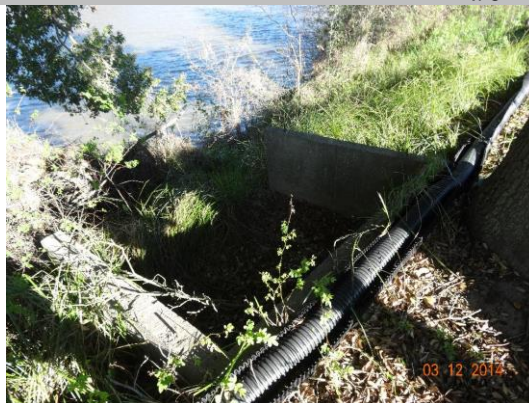
Photo 1 of 3 : UCIP_SP_2018_32018_58469.jpg

Comment Code					
Inspector Comment					
FS_ID:32018 DS_ID:20897 EP_NO: N/A Repair Type: Non-Urgent Crossing Status: Indicator Found UCIP Comments: Unable to determine status of crossing--was crossing removed during erosion repair site in 2007-2009? Need to coordinate with LMA or owner to obtain additional information about crossing. FIELD_STRUCT_DESC: *ABANDONED* 6-inch irrigation pipe of unknown material through the levee, 1.0-foot below the crown. Concrete pump pad on the waterside (WS) slope. [Additional Reference(s): DWR Levee Log, 1983 and 2005. USACE Sacramento O&M Manual Unit No. 111, May 1959, revised 29 Dec 2016, (River Mile [RM] 27.00)] FS Date: 3/12/2014

Concrete U wall located on waterward side.

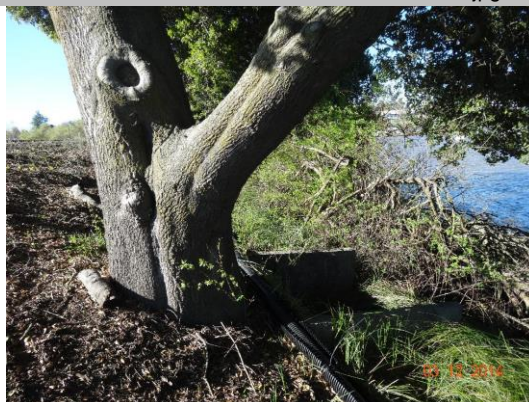
Photo 2 of 3 : UCIP_SP_2018_32018_58468.jpg

Concrete vault located on waterward side. Site is a erosion repair site.

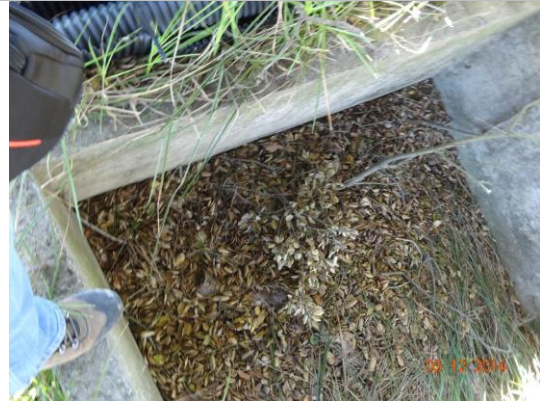
Photo 3 of 3 : UCIP_SP_2018_32018_58467.jpg

Comment Code					
Inspector Comment					
FS_ID:32018 DS_ID:20897 EP_NO: N/A Repair Type: Non-Urgent Crossing Status: Indicator Found UCIP Comments: Unable to determine status of crossing--was crossing removed during erosion repair site in 2007-2009? Need to coordinate with LMA or owner to obtain additional information about crossing. FIELD_STRUCT_DESC: *ABANDONED* 6-inch irrigation pipe of unknown material through the levee, 1.0-foot below the crown. Concrete pump pad on the waterside (WS) slope. [Additional Reference(s): DWR Levee Log, 1983 and 2005. USACE Sacramento O&M Manual Unit No. 111, May 1959, revised 29 Dec 2016, (River Mile [RM] 27.00)] FS Date: 3/12/2014

Concrete face no outlet visible on waterward side.

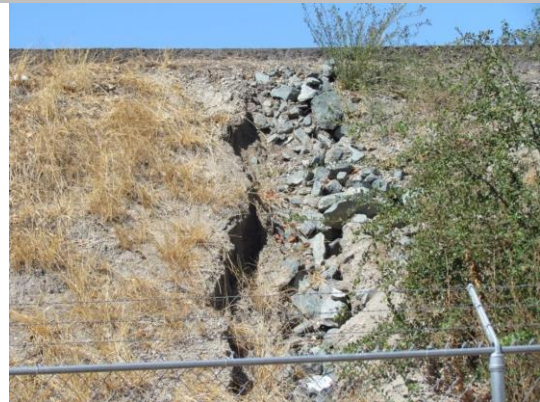
Photo 1 of 3 : SP_2018_RD0554_176_13_20180305_00004.jpg

LM Start	0.32	Rating **	U	Issue No.	13
LM End	0.32	Issue Type +	Ma	Location *	LS
Category	Earthen Levee			GPS Latitude/Longitude	
				Start	End
Item	Erosion / Bank Caving			38.245389 °	38.245389 °
				-121.511085 °	-121.511085 °
DWR ID	DWR_RD0554_01_s_2014_13				
Comment Code					
E2 : Schedule repair of erosion site prior to the next inspection.					
Inspector Comment					
This erosion isn't repaired to date. Large bush growing in eroded gully. Needs repairing.

This erosion along the landside levee slope is not new, it was reported two years ago.

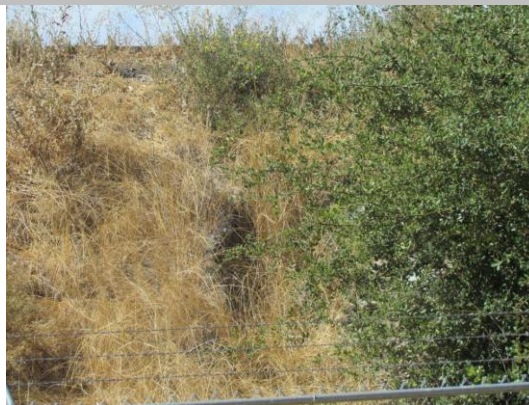
Photo 2 of 3 : SP_2018_RD0554_176_13_20180305_00005.jpg

LM Start	0.32	Rating **	U	Issue No.	13 (cont)	
LM End	0.32	Issue Type +	Ma	Location *	LS	
Category	Earthen Levee			GPS Latitude/Longitude		
				Start		End
Item	Erosion / Bank Caving			38.245389 °		38.245389 °
				-121.511085 °		-121.511085 °
DWR ID	DWR_RD0554_01_s_2014_13					
Comment Code						
E2 : Schedule repair of erosion site prior to the next inspection.						
Inspector Comment						
This erosion isn't repaired to date. Large bush growing in eroded gully. Needs repairing.

This erosion site along the landside slope levee 0.32 has been reported and has not been repaired.

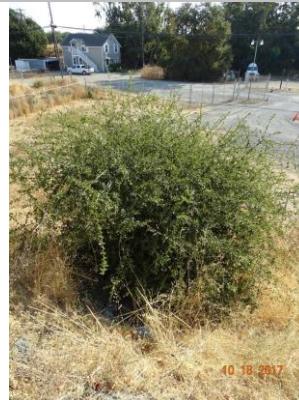
Photo 3 of 3 : SP_2018_RD0554_176_13_20180305_00006.jpg

LM Start	0.32	Rating **	U	Issue No.	13 (cont)
LM End	0.32	Issue Type +	Ma	Location *	LS

This erosion is not repaired to date. Large bush growing in eroded gully. Needs repairing.

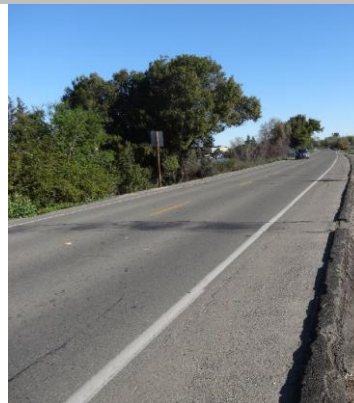
Photo 3 of 3 : UCIP_SP_2018_43694_58062.jpg

Signs of cut through levee at conduit.

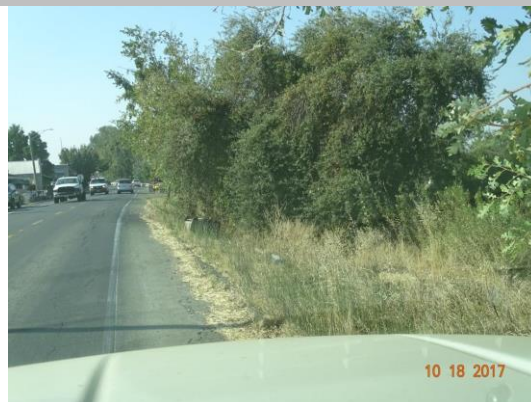
Photo 1 of 1 : SP_2018_RD0554_176_32_20180305_00010.jpg

LM Start	0.36	Rating **	A/W	Issue No.	15
LM End	0.41	Issue Type +	Ob	Location *	WS
Category	Earthen Levee			GPS Latitude/Longitude	
				Start	End
Item	Vegetation			38.244872 °	38.244308 °
				-121.511600 °	-121.512057 °
DWR ID	DWR_RD0554_01_s_2014_15				
Comment Code					
V8 : Environmental Requirements.					
Inspector Comment					
Veg. Site.

Waterside vegetation should be cleared to 20 feet from crown for inspection and access.

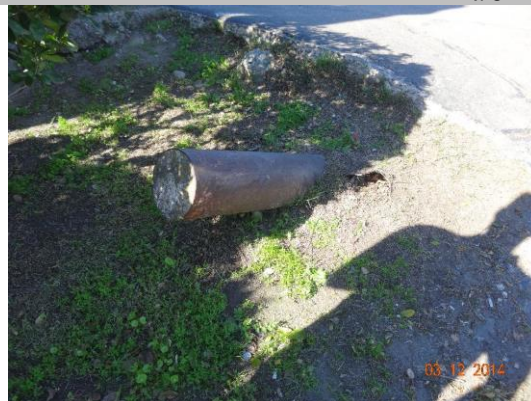
Photo 1 of 1 : UCIP_SP_2018_32020_58473.jpg

Comment Code					
Inspector Comment					
FS_ID:32020 DS_ID:20912 EP_NO: 11154 Repair Type: Non-Urgent Crossing Status: Indicator Found UCIP Comments: Unable to confirm if this pipe section is the same one listed under 11154. Need to contact owner to determine status and obtain additional information about crossing. FIELD_STRUCT_DESC: *ABANDONED* 8-inch pipe of unknown material or purpsoe through the levee, 9.8 feet below the crown. Pump on landside (LS) toe. (8-inch pipe retained under Automatic Board Order (ABO) issued as Permit No. 11154, 1975 - M.M. & H.L. Brown, two 4-inch [HLM 0.75]) [Additional Reference(s): DWR Levee Log, 1983 and 2005. USACE Sacramento O&M Manual Unit No. 111, May 1959, revised 29 Dec 2016, (River Mile [RM] 26.66)] FS Date: 3/12/2014

Steel pipe filled with concrete visible on landward shoulder.

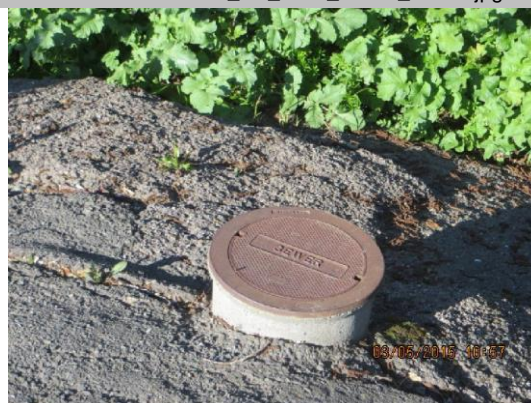
Photo 1 of 3 : UCIP_SP_2018_43805_73320.jpg

LM Start	0.64	Rating **	M	Issue No.	47
LM End	0.64	Issue Type +	En	Location *	
Category	Supplemental			GPS Latitude/Longitude	
				Start	End
Item	DWR UCIP Field Study			38.241550 °	38.241550 °
				-121.514535 °	-121.514535 °
DWR ID					
Comment Code					
Inspector Comment					
FS_ID:43805					
DS_ID:25080					
EP_NO: N/A					
Repair Type: Non-Urgent					
Crossing Status: Found					
UCIP Comments: No permit found. Further investigation required.					
FIELD_STRUCT_DESC: 4-inch cast iron sewer pipe through the levee at an unknown depth. Pipe visible on bridge. Sewer cleanout on waterside (WS) shoulder and cut in pavement visible in roadway. (4-inch pipe authorized under Permit No. 870, 1941 - Shell Oil Company, incorporated)					
FS Date: 3/5/2015

Sewer cleanout on WS shoulder.

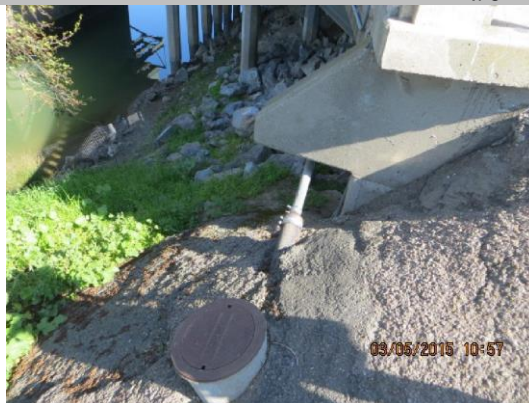
Photo 2 of 3 : UCIP_SP_2018_43805_73321.jpg

LM Start	0.64	Rating **	M	Issue No.	47 (cont)	
LM End	0.64	Issue Type +	En	Location *		
Category	Supplemental			GPS Latitude/Longitude		
				Start	End	
Item	DWR UCIP Field Study			38.241550 °	38.241550 °	
				-121.514535 °	-121.514535 °	
DWR ID						
Comment Code						
Inspector Comment						
FS_ID:43805						
DS_ID:25080						
EP_NO: N/A						
Repair Type: Non-Urgent						
Crossing Status: Found						
UCIP Comments: No permit found. Further investigation required.						
FIELD_STRUCT_DESC: 4-inch cast iron sewer pipe through the levee at an unknown depth. Pipe visible on bridge. Sewer cleanout on waterside (WS) shoulder and cut in pavement visible in roadway. (4-inch pipe authorized under Permit No. 870, 1941 - Shell Oil Company, incorporated)						
FS Date: 3/5/2015

Pipe visible at bridge on WS shoulder.

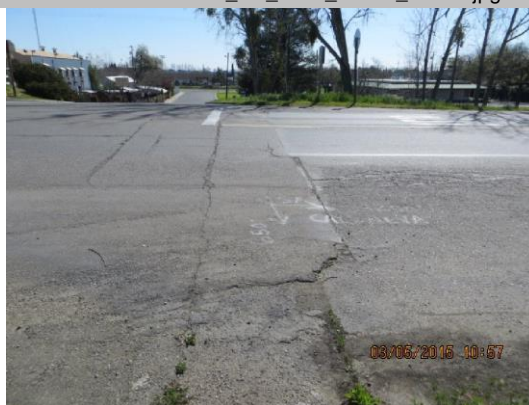
Photo 3 of 3 : UCIP_SP_2018_43805_73322.jpg

LM Start	0.64	Rating **	M	Issue No.	47 (cont)
LM End	0.64	Issue Type +	En	Location *

Cut in pavement at pipe alignment.

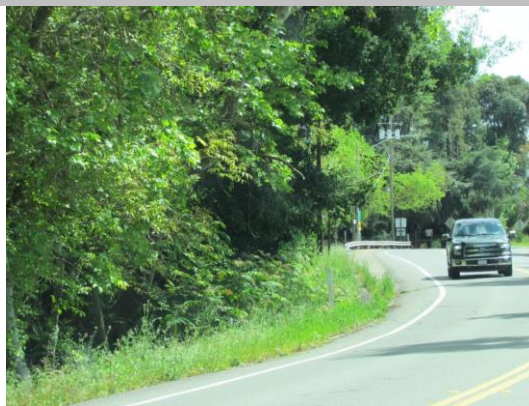
Photo 1 of 1 : SP_2018_RD0554_176_30_20180305_00008.jpg

Looking downstream at the wild growth on the landside levee slope.

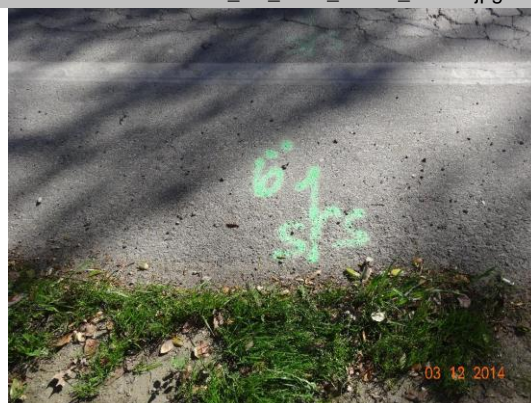
Photo 1 of 3 : UCIP_SP_2018_32021_58475.jpg

LM Start	0.89	Rating **	M	Issue No.	48
LM End	0.89	Issue Type +	En	Location *	
Category	Supplemental			GPS Latitude/Longitude	
				Start	End
Item	DWR UCIP Field Study			38.238595 °	38.238595 °
				-121.516945 °	-121.516945 °
DWR ID					
Comment Code					
Inspector Comment					
FS_ID:32021 DS_ID:20941 EP_NO: N/A Repair Type: Non-Urgent Crossing Status: Indicator Found UCIP Comments: Unable to confirm how many sewer lines cross levee. Desk study shows 2 crossings 4-inch not 6 inch. Need to contact owner to confirm status of crossing. FIELD_STRUCT_DESC: 1 of 2: 4-inch clay sewer pipe through the levee, 10.2 feet below the crown. (USACE-1959). This entry matches the Drainage or Irrigation Structure referenced in O&M manual (RM 26.50). FS Date: 3/12/2014 2:06:00 PM

Underground service alert (USA) markers confirming sewer line.

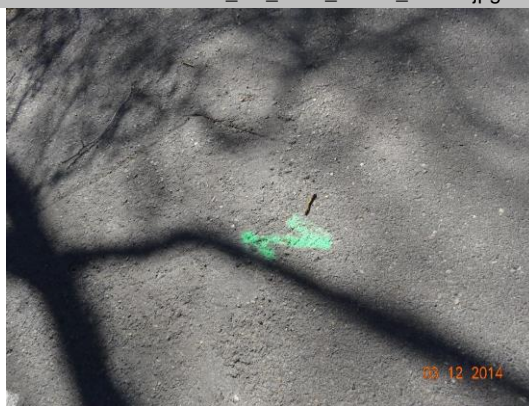
Photo 3 of 3 : UCIP_SP_2018_32021_58477.jpg

LM Start	0.89	Rating **	M	Issue No.	48 (cont)	
LM End	0.89	Issue Type +	En	Location *		
Category	Supplemental			GPS Latitude/Longitude		
				Start	End	
Item	DWR UCIP Field Study			38.238595 °	38.238595 °	
				-121.516945 °	-121.516945 °	
DWR ID						
Comment Code						
Inspector Comment						
FS_ID:32021 DS_ID:20941 EP_NO: N/A Repair Type: Non-Urgent Crossing Status: Indicator Found UCIP Comments: Unable to confirm how many sewer lines cross levee. Desk study shows 2 crossings 4-inch not 6 inch. Need to contact owner to confirm status of crossing. FIELD_STRUCT_DESC: 1 of 2: 4-inch clay sewer pipe through the levee, 10.2 feet below the crown. (USACE-1959). This entry matches the Drainage or Irrigation Structure referenced in O&M manual (RM 26.50). FS Date: 3/12/2014 2:06:00 PM

View of USA marker on waterward side.

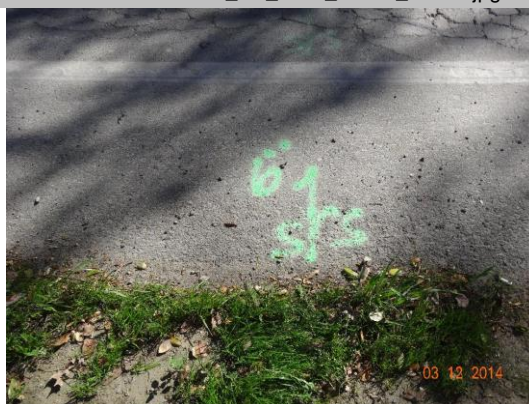
Photo 1 of 3 : UCIP_SP_2018_32022_58480.jpg

LM Start	0.89	Rating **	M	Issue No.	49
LM End	0.89	Issue Type +	En	Location *	
Category	Supplemental			GPS Latitude/Longitude	
				Start	End
Item	DWR UCIP Field Study			38.238595 °	38.238595 °
				-121.516945 °	-121.516945 °
DWR ID					
Comment Code					
Inspector Comment					
FS_ID:32022 DS_ID:20942 EP_NO: N/A Repair Type: Non-Urgent Crossing Status: Indicator Found UCIP Comments: Unable to confirm how many sewer lines cross levee. Desk study shows 2 crossings 4-inch not 6 inch. Need to contact owner to confirm status of crossing. FIELD_STRUCT_DESC: 2 of 2: 4-inch clay sewer pipe through the levee, 10.2 feet below the crown. (USACE-1959). This entry matches the Drainage or Irrigation Structure referenced in O&M manual (RM 26.50). FS Date: 3/12/2014

Underground service alert (USA) marker on waterward shoulder for sewer line.

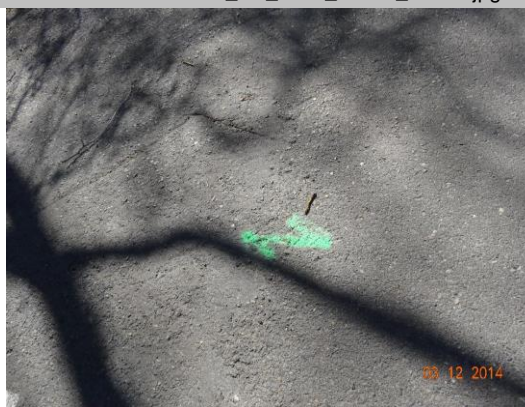
Photo 3 of 3 : UCIP_SP_2018_32022_58478.jpg

LM Start	0.89	Rating **	M	Issue No.	49 (cont)
LM End	0.89	Issue Type +	En	Location *

View of landward shoulder--USA marker.

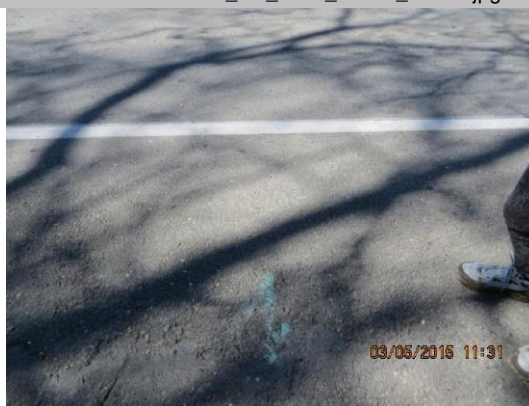
Photo 1 of 3 : UCIP_SP_2018_43804_73323.jpg

LM Start	0.89	Rating **	M	Issue No.	50	
LM End	0.89	Issue Type +	En	Location *		
Category	Supplemental			GPS Latitude/Longitude		
				Start	End	
Item	DWR UCIP Field Study			38.238510 °	38.238510 °	
				-121.516948 °	-121.516948 °	
DWR ID						
Comment Code						
Inspector Comment						
FS_ID:43804						
DS_ID:25081						
EP_NO: N/A						
Repair Type: Non-Urgent						
Crossing Status: Indicator Found						
UCIP Comments: No permit identified for crossing. Further investigation required.						
FIELD_STRUCT_DESC: 6-inch steel sewer pipe through the levee at an unknown depth below the levee crown. USAA markings on pavement indicate crossing at center of ramp on landside (LS) slope.						
FS Date: 3/5/2015

USAA SS marking on LS shoulder.

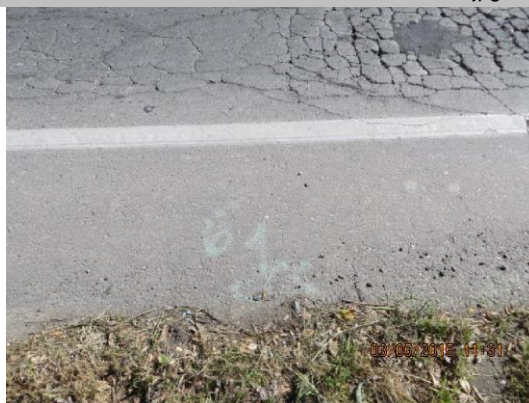
Photo 2 of 3 : UCIP_SP_2018_43804_73324.jpg

LM Start	0.89	Rating **	M	Issue No.	50 (cont)
LM End	0.89	Issue Type +	En	Location *

USAA SS marking on LS shoulder.

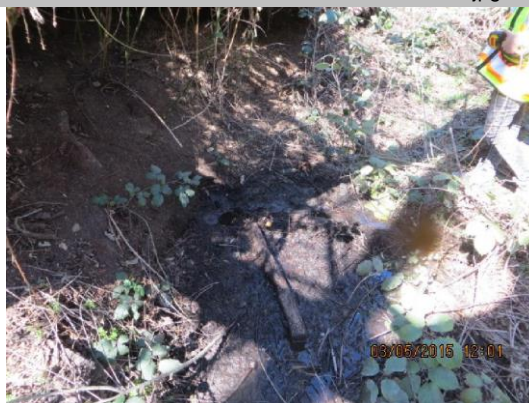
Photo 3 of 3 : UCIP_SP_2018_50027_73246.jpg

Pipe leak at LS toe 23 ft upstream from pumphouse.

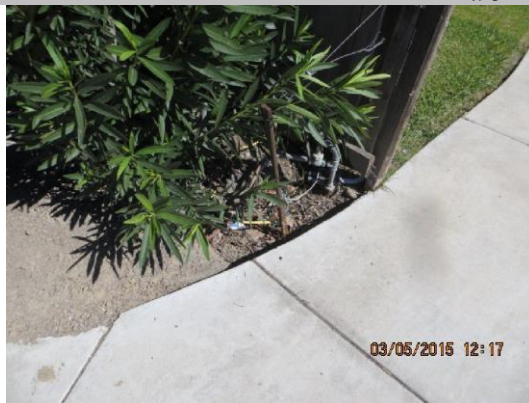
Photo 1 of 3 : UCIP_SP_2018_43810_73328.jpg

LM Start	1.09	Rating **	M	Issue No.	52
LM End	1.09	Issue Type +	En	Location *	
Category	Supplemental			GPS Latitude/Longitude	
				Start	End
Item	DWR UCIP Field Study			38.235743 °	38.235743 °
				-121.517032 °	-121.517032 °
DWR ID					
Comment Code					
Inspector Comment					
FS_ID:43810 DS_ID:25083 EP_NO: N/A Repair Type: Non-Urgent Crossing Status: Found UCIP Comments: No permit identified for crossing. Further investigation required. FIELD_STRUCT_DESC: Two 1-inch conduits through the levee, 1-foot below the levee crown. Valves appear to be installed on landside (LS) shoulder. Dock on waterside (WS) slope. FS Date: 3/5/2015

Pipes visible at LS shoulder next to driveway.

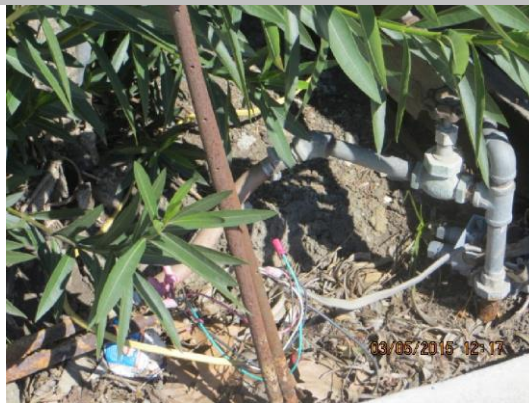
Photo 2 of 3 : UCIP_SP_2018_43810_73329.jpg

LM Start	1.09	Rating **	M	Issue No.	52 (cont)
LM End	1.09	Issue Type +	En	Location *

Pipes and valves visible on LS shoulder.

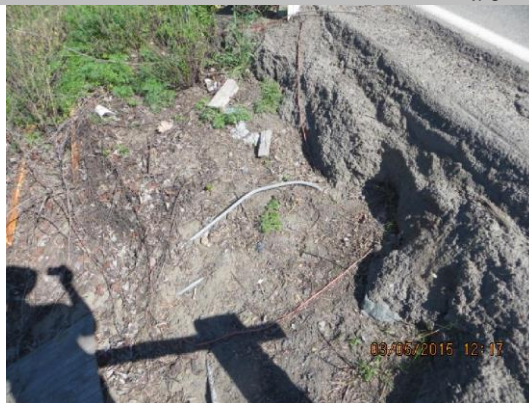
Photo 3 of 3 : UCIP_SP_2018_43810_73330.jpg

LM Start	1.09	Rating **	M	Issue No.	52 (cont)	
LM End	1.09	Issue Type +	En	Location *		
Category	Supplemental			GPS Latitude/Longitude		
				Start	End	
Item	DWR UCIP Field Study			38.235743 °	38.235743 °	
				-121.517032 °	-121.517032 °	
DWR ID						
Comment Code						
Inspector Comment						
FS_ID:43810						
DS_ID:25083						
EP_NO: N/A						
Repair Type: Non-Urgent						
Crossing Status: Found						
UCIP Comments: No permit identified for crossing. Further investigation required.						
FIELD_STRUCT_DESC: Two 1-inch conduits through the levee, 1-foot below the levee crown. Valves appear to be installed on landside (LS) shoulder. Dock on waterside (WS) slope.						
FS Date: 3/5/2015

Possible outlet on WS shoulder.

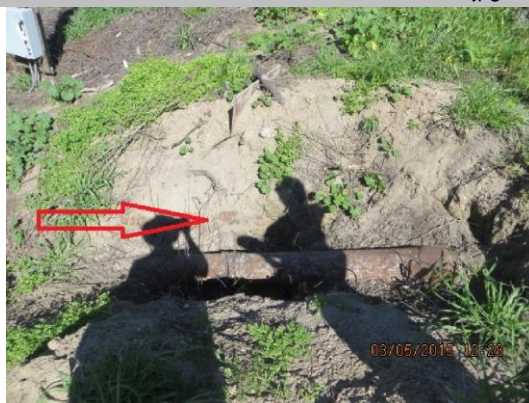
Photo 1 of 1 : UCIP_SP_2018_43747_73286.jpg

LM Start	1.11	Rating **	M	Issue No.	53
LM End	1.11	Issue Type +	En	Location *	
Category	Supplemental			GPS Latitude/Longitude	
				Start	End
Item	DWR UCIP Field Study			38.235429 °	38.235429 °
				-121.517169 °	-121.517169 °
DWR ID					
Comment Code					
Inspector Comment					
FS_ID:43747 DS_ID:20930 EP_NO: N/A Repair Type: Non-Urgent Crossing Status: Found UCIP Comments: Pipe should be abandoned properly. Pipe was visible just upstream of other pipe that was exposed for repair on WS slope. FIELD_STRUCT_DESC: *ABANDONED* 8-inch steel irrigation pipe through the levee, 3.7-feet below the crown. Pump located on the waterside (WS). Pipe is buried/abandoned in-place. [Additional Reference(s): USACE Sacramento O&M Manual Unit No. 111, May 1959, revised 29 Dec 2016, (River Mile [RM] 26.10)] FS Date: 3/5/2015

Abandoned pipe was exposed on WS slope when a trench was opened to repair the other 8-inch pipe at the site.

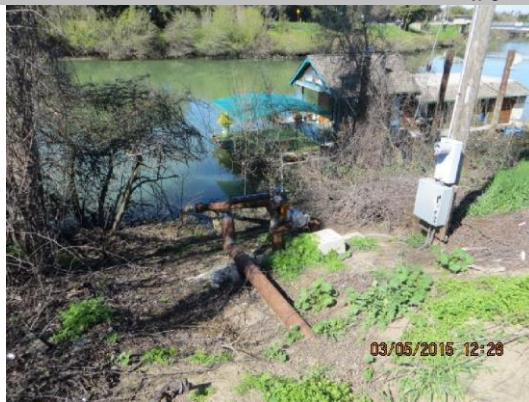
Photo 2 of 3 : UCIP_SP_2018_43748_73288.jpg

Pipe exposed on WS slope. pump, shutoff valve, and meter on pole on WS slope.

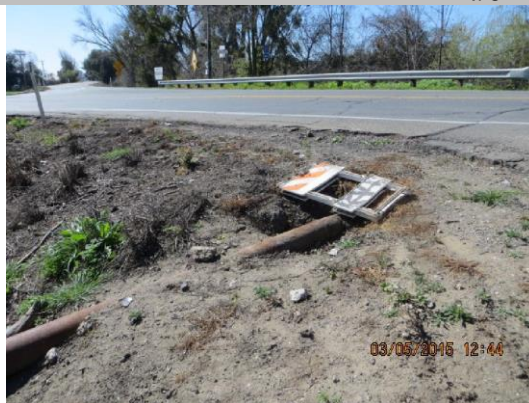
Photo 3 of 3 : UCIP_SP_2018_43748_73287.jpg

Pipe exposed on LS shoulder.
